# Schedule of Condition

Property Address:	Dog & Partridge Hotel 44 Friargate Preston PR1 2AT		
Property Reference Number:	2302619101		
	DB/tb	Rev.	
Survey Date	18 <sup>th</sup> April 2019

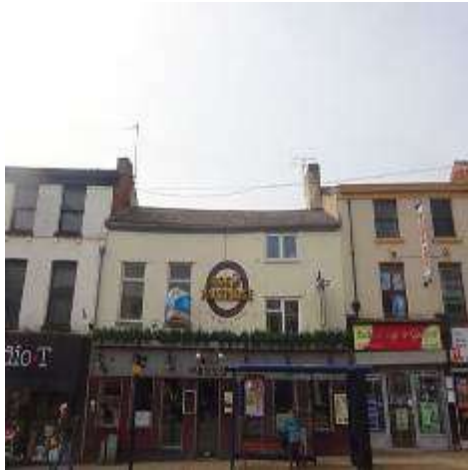
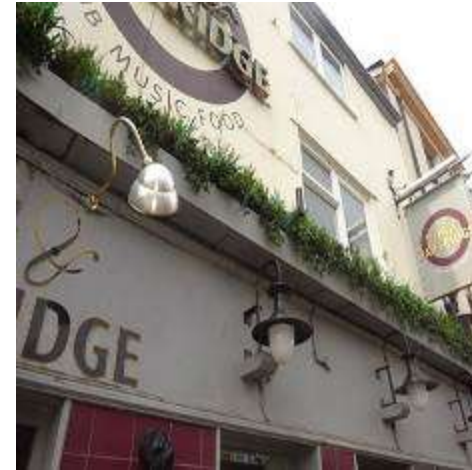
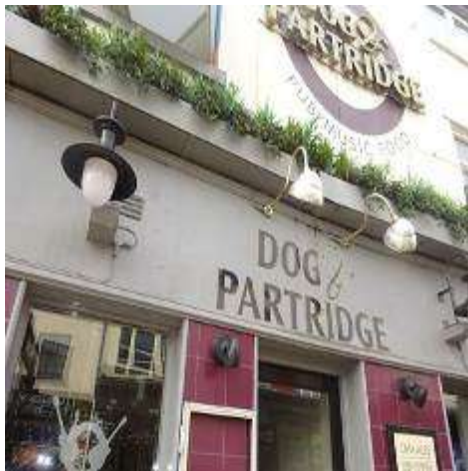
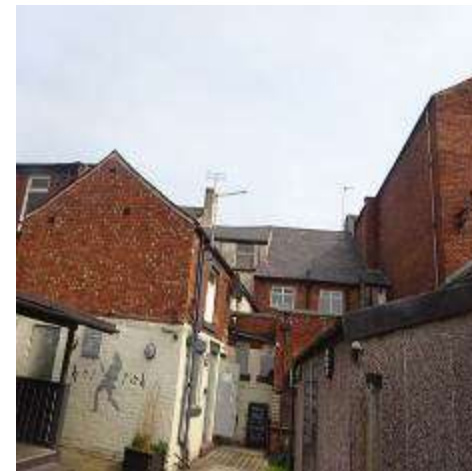
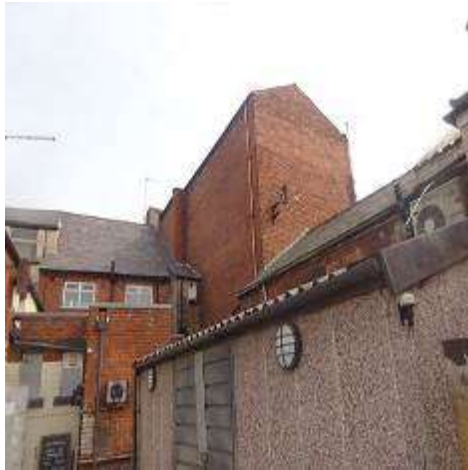
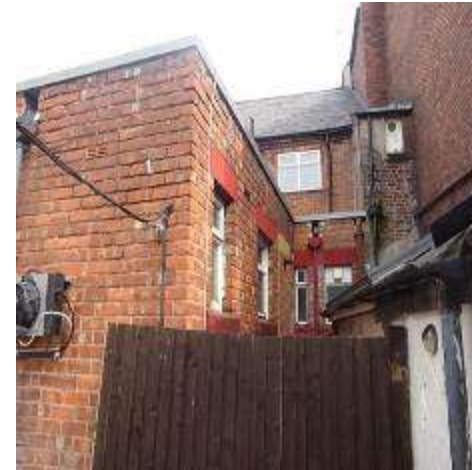
Item	Location	Description	Condition Yr0	Condition Re-inspection No 1	Condition Re-inspection No 2	Condition Re-inspection No 3
<b>5</b>	<b>EXTERNAL</b>		<b>Photos 001 to 012</b>			
<b>5.1</b>	<b>Main two the three public house building front elevation</b>					
<b>5.1.1</b>	<b>Roof</b>	Pitch roof structure overlaid with slate roof covering.	2 With dating to roof covering installation.			
<b>5.1.2</b>	<b>Chimney stack installation</b>	Rendered covered chimney stack installation at main roof level.	2-1 With patch repairs evident to rendered surfaces and deterioration to decorative finishes present.			
<b>5.1.3</b>	<b>Rainwater goods</b>	Consist of lead lined guttering systems at main roof level with downpipe installations.	2			
<b>5.1.4</b>	<b>External walls</b>	Consist of rendered wall surfaces with paint finish.	2 With some slight deterioration to decorative surfaces present.			
<b>5.1.5</b>	<b>External joinery</b>	Consist of timber window frame and uPVC installation.	2 With slight deterioration to decorative surfaces to timber window frame installations.

<b>5.1.6</b>	<b>Tile wall frontages</b>	Located at low level with decorative signage and plant.	2-1 With corrosion developing to plant and staining to sign along with wall tiling.

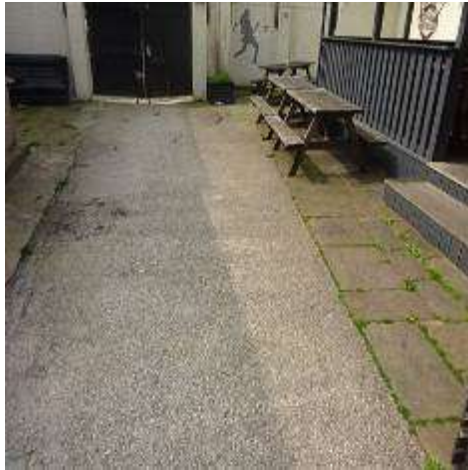
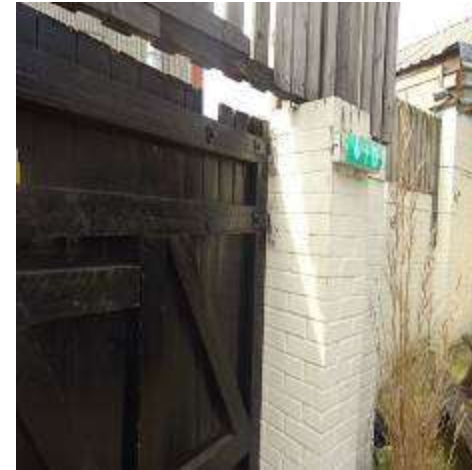
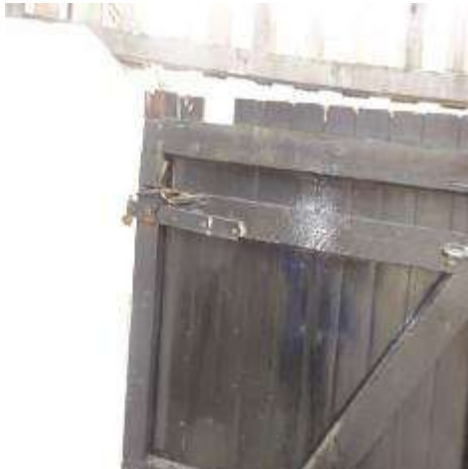
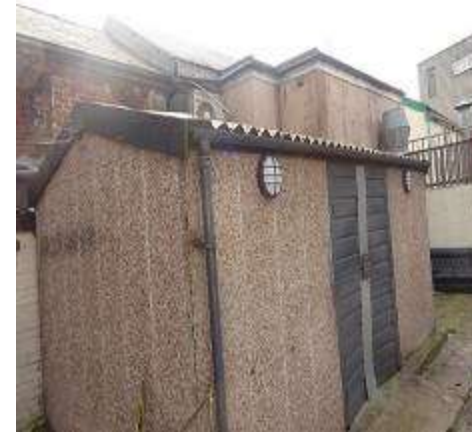
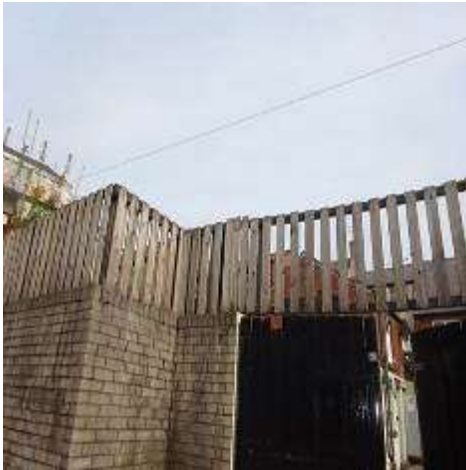
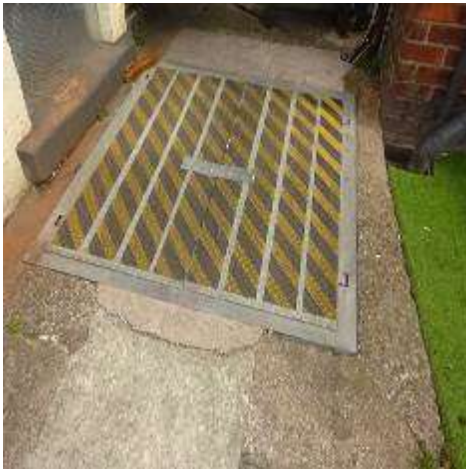
6.1	<b>SITE AREAS</b>		<b>Photos 013 to 018</b>			
6.1.1	Rear elevation seating and service yard area	A concrete covered and paving slab cover service yard and rear seating area are located behind public house.	2-1 With random cracking to concrete surfaces and some unevenness to paving slab with weeds and grasses growing through installations.

Item	Location	Description	Condition Yr0	Condition Re-inspection No 1	Condition Re-inspection No 2	Condition Re-inspection No 3
6.1.2	Internal and external walls, fences and boundaries	Consist of brickwork wall structures, timber gates and adjoining building.	2-1 With bushes growing in and around the rear to right hand side boundary wall structure adjacent to covered seating area with rot developing to the two timber double gates that access the service yard with random disrepair to various wall structures and adjoining building which are extremely dated in some locations.

6.1.3	Covered seating area to rear of public house.	A covered timber seating area is located to rear of public house.	2			
6.1.4	External garage to rear of public house	A concrete garage with cement profile sheet roof covering is located to rear of public house.	2-1 With rot developing to timber door frame to installation with some build up of moss and lichen to roof cover and general disrepair evident to this installation.

6.1.5	Timber fencing on top of rear boundary wall	A timber fencing is located on top of the rear boundary wall.	2-1 With rot developing to installation with no staining present.

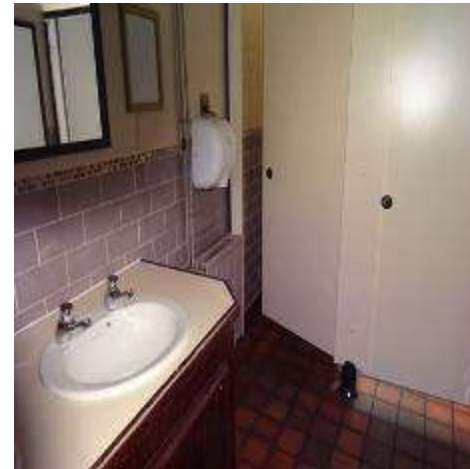
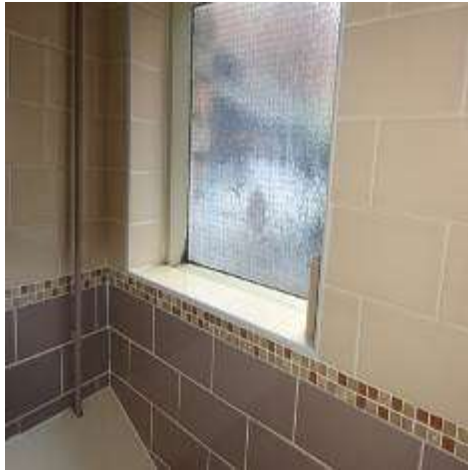
1.3	Ground floor central ladies w.c		Photos 028 to 029			
1.3.1	Ceiling	Plastered ceilings with emulsion paint finish.	2 With some cracking and staining to decorative surfaces.

Item	Location	Description	Condition Yr0	Condition Re-inspection No 1	Condition Re-inspection No 2	Condition Re-inspection No 3
1.3.2	Walls	Plastered walls with grout finish.	2 With newer installation.

1.3.3	Floor	Quarry tile covered floor surface.	2			
1.3.4	Internal joinery	Consist of internal face of external windows, internal doors, door frames.	2-1 With heavy staining to internal face of external window frames.

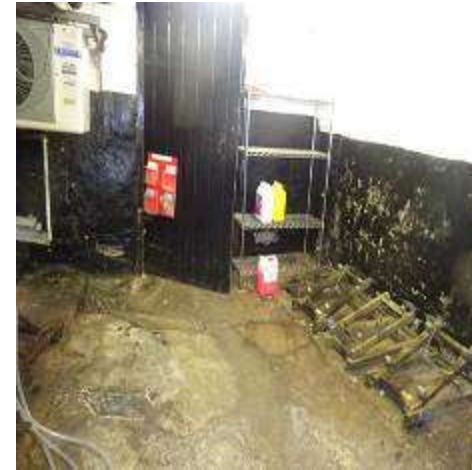
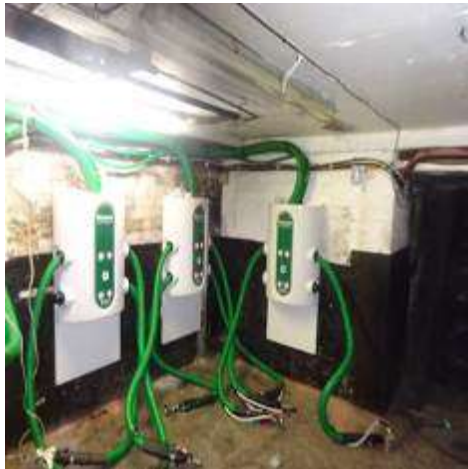
2.0	<b>BASEMENT</b>		<b>Photos 034 to 035</b>			
2.1	<b>Steps leading down to and including basement cellar areas</b>					
2.1.1	Ceiling	Plastered and boarded ceiling surfaces with paint finish.	2-1 Some heavy staining to ceiling surface due to cellar location.

2.1.2	Walls	Masonry wall with paint finishes.	2 With dampness to wall surface due to cellar location.			
2.1.3	Floor	Concrete floor structure.	2-1 With heavy cracking and dating to floor surfaces which are showing heavy wear and tear in this high traffic use location.

2.1.4	Internal joinery	Consists internal doors, door frames etc.	2 Chipping and wear and tear typical of this high traffic use location.			
3.0	<b>FIRST FLOOR</b>

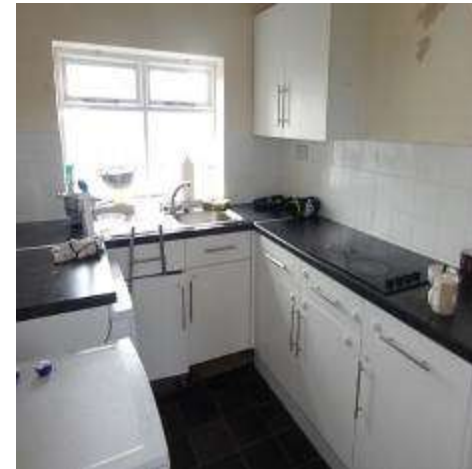
**Photo 044**

3.2.6	Radiator	Chrome radiator.	2			
3.3	<b>First floor publican residence central to kitchen</b>		<b>Photos 044</b>			
3.3.1	Ceiling	Plastered ceilings with emulsion paint finish.	2-1 Damage to ceiling surface.

3.3.2	Walls	Plastered walls with emulsion paint finish and ceramic wall tile covered wall surface.	2 With some staining and deterioration to decorative finish with possible dampness.

Item	Location	Description	Condition Yr0	Condition Re-inspection No 1	Condition Re-inspection No 2	Condition Re-inspection No 3
3.3.5	Kitchen installation	Consists of wall cupboards, base units, worktops and inlaid metal sink top.	2 With some wear and tear to kitchen installations due to use and some uncleanliness present.
