Schedule of Condition

Property Address:	Damm 27, 25-29 Causewayside, Edinburgh, EH9 1QF		
Property Reference Number:	2302333101		
Document Reference:	LS/kmc	Rev.	
Survey Date:	15 th September 2021

The property comprises a ground floor public house in a four-storey block to the centre of a parade. No access to any rear elevation to the premises. The frontage to the subject property is all formed in timber with glazing to windows. The building of which the subject demise forms a small part of has rough render finishes to the front facing elevation which is set beneath a pitched roof overlaid in slate. The roofs incorporate dormer projections with sash windows at first, second and dormer level. Rainwater goods are in cast iron.

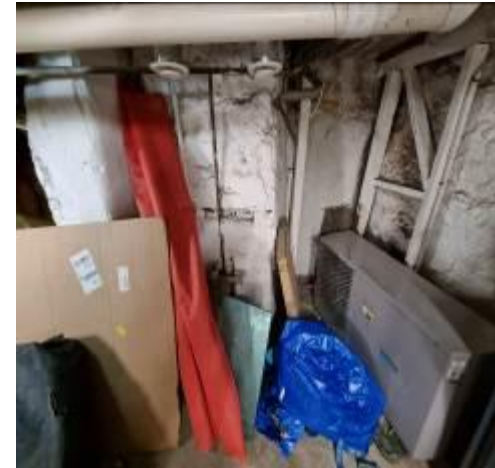
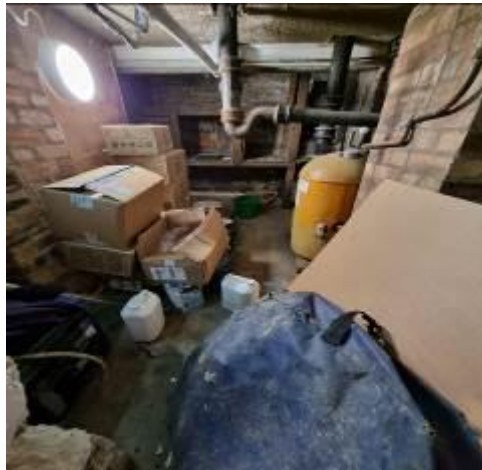
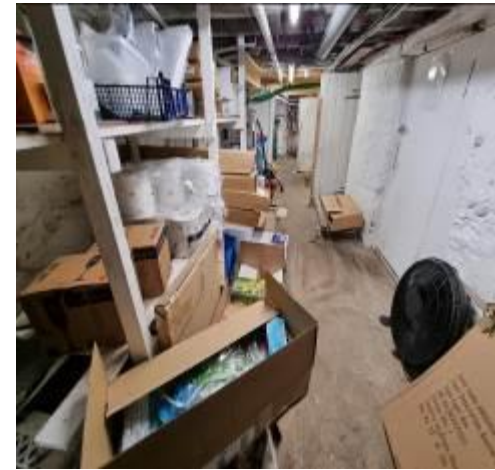
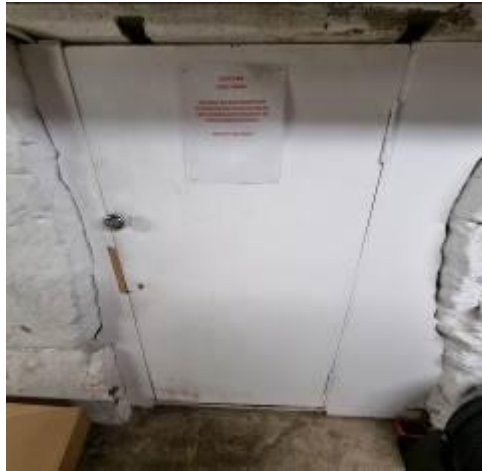
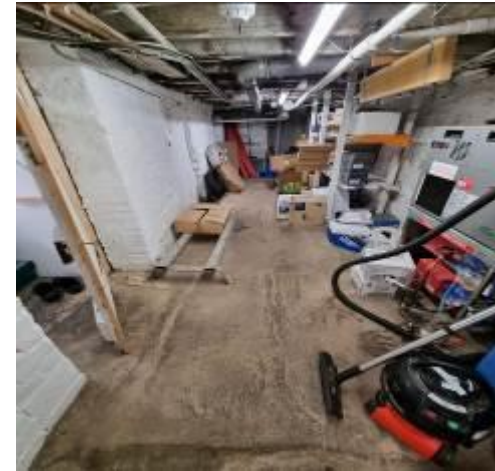
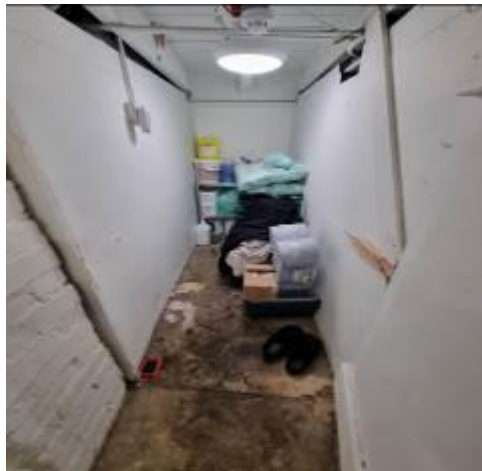
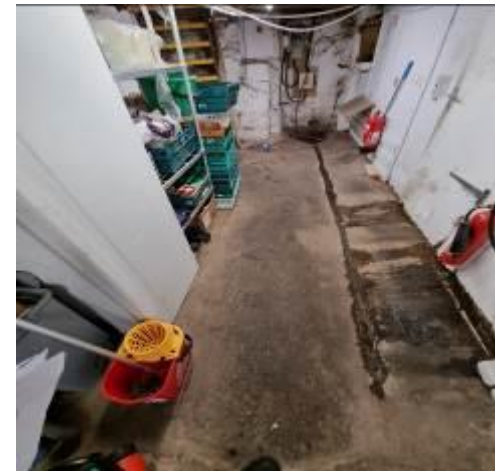
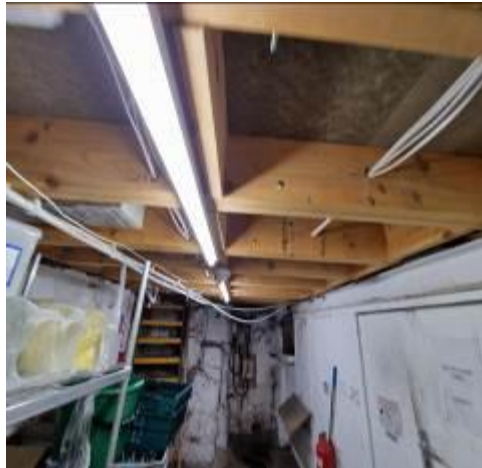
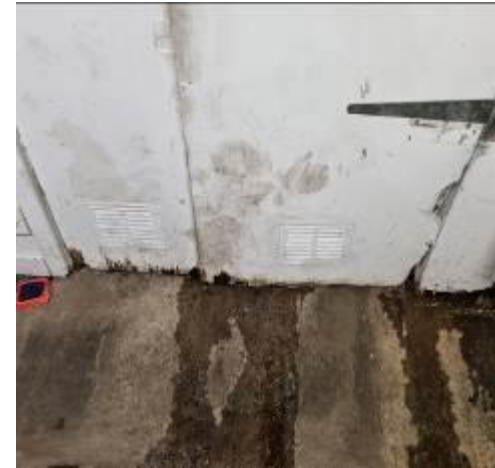
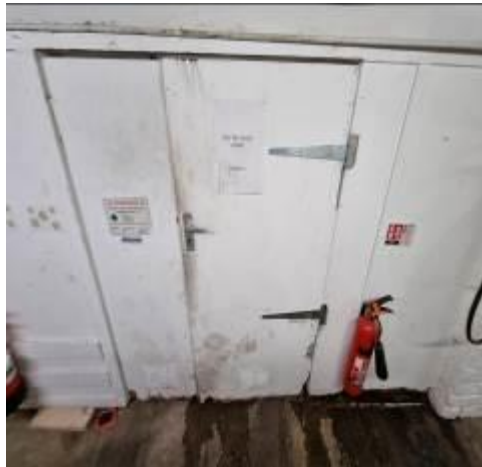
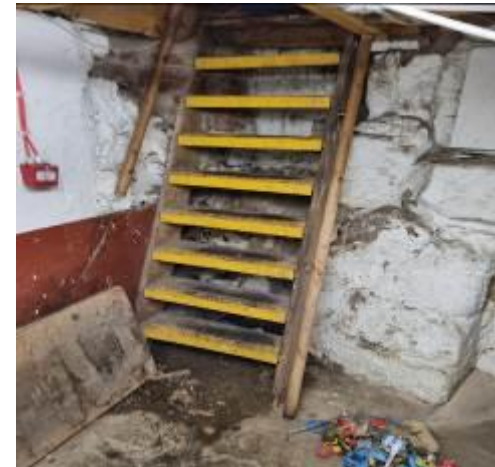
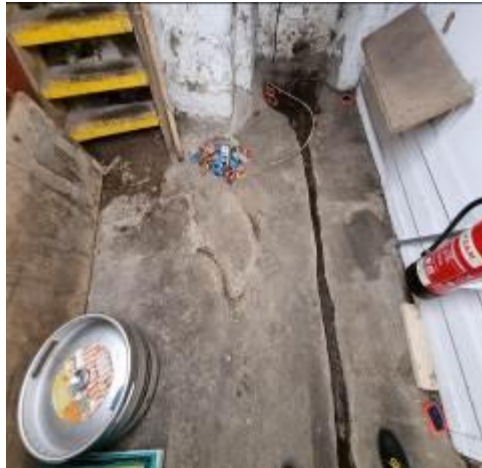
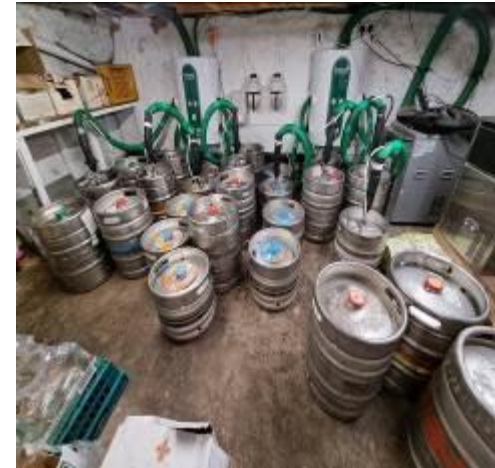
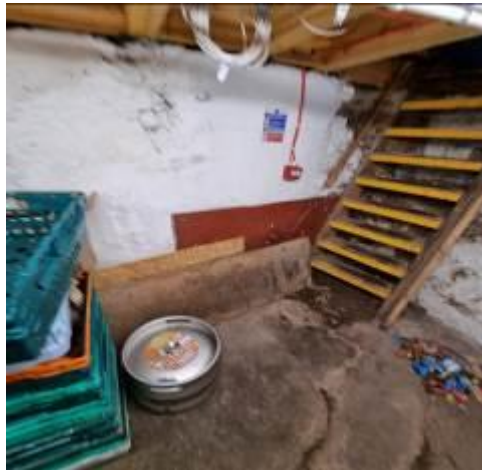
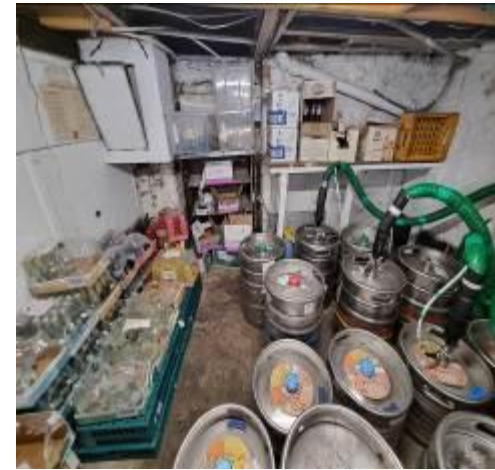
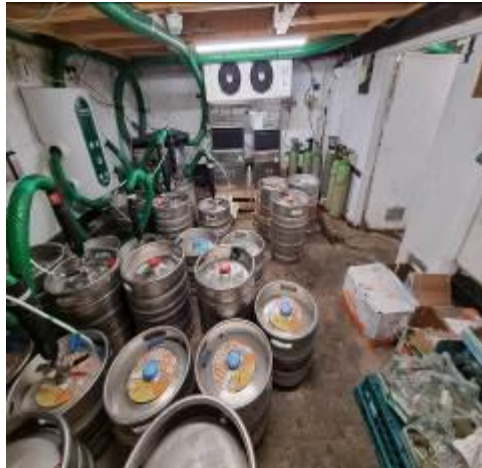
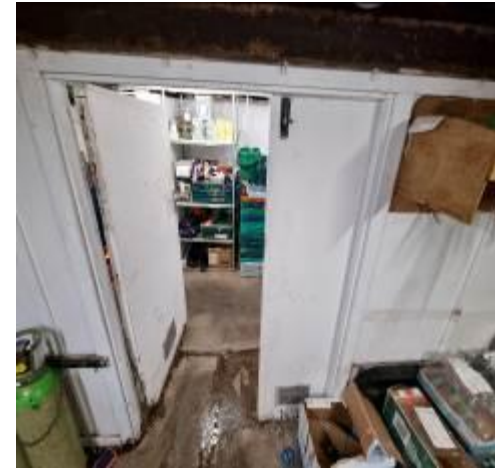
Item	Location	Description	Condition Yr0	Condition Re-inspection No 1	Condition Re-inspection No 2	Condition Re-inspection No 3
2.0	BASEMENT		Photos 30-47

2.1	Cellar areas					
2.1.1	Ceiling	Suspended timber floor to right hand side with replacement sections provided to front part of the accommodation. Suspended concrete floor forms the ceiling over the rear left hand part of the accommodation (limited inspection).	2 Defects evident. Limited inspection to edges.

2.1.2	Walls	Solid walls largely with paint finish provided.	2 Some impact damage evident. Significant deterioration noted. Some deterioration around drop area and metal protective pad provided to right hand wall.

2.1.3	Floor	Solid concrete floor with screed finish provided. Sections incorporate gulley.	2 Wear and tear but no significant deterioration except to bottom of drop.

2.1.4	Cooler unit	Set to rear wall within front beer cellar area.	2 In use of timber of inspection. Untested.			
2.1.5	Shelving	Fixed shelving within front beer cellar area.	1 Crudely formed and impact damaged.

Item	Location	Description	Condition Yr0	Condition Re-inspection No 1	Condition Re-inspection No 2	Condition Re-inspection No 3
2.1.6	Doors	Flush faced timber doors and surrounding screen dividing front beer cellar area from delivery area.	1 to 2 Damage to door.

2.1.7	Drop	Timber steeply sited steps with metal edges to runners.	1 to 2 Impact damaged but serviceable.			
2.1.8	Doors 2	Timber panelled door to central store area.	1 Ill fitting.

2.1.9	Doors 3	Flush faced door (locked) to central storage area. Appears adequate for purposes.	2			
2.1.10	Pipework	Cast iron pipework to rear left hand part of room.	1 Evidence of corrosion to sections. No evidence of any significant leakage at time of inspection.

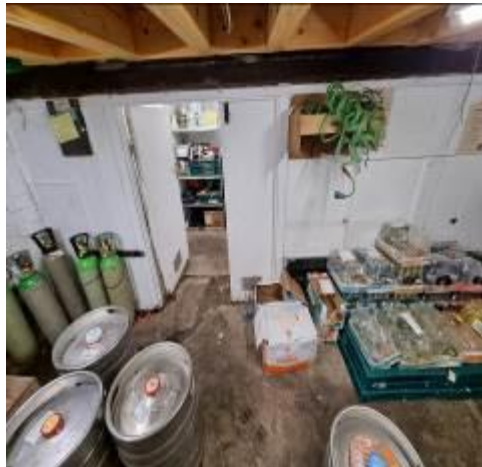
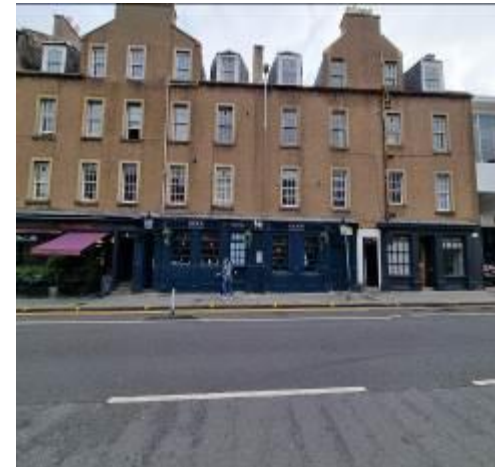
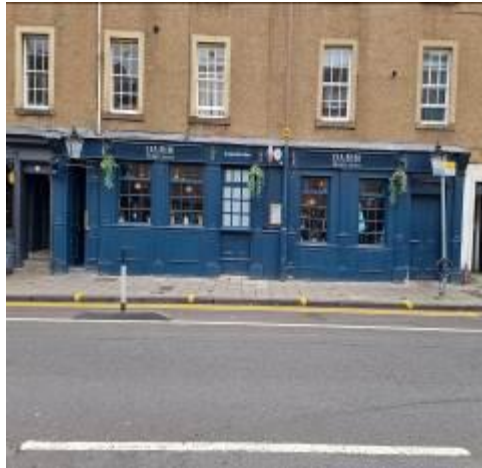
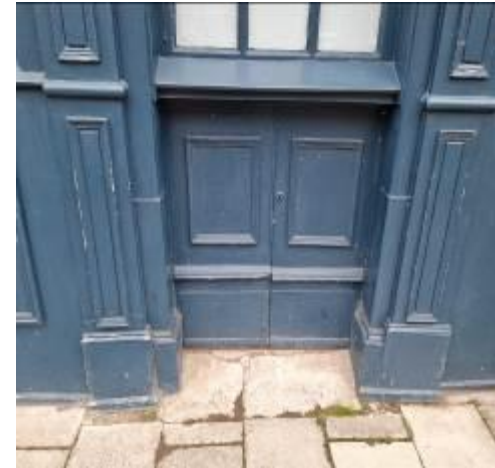
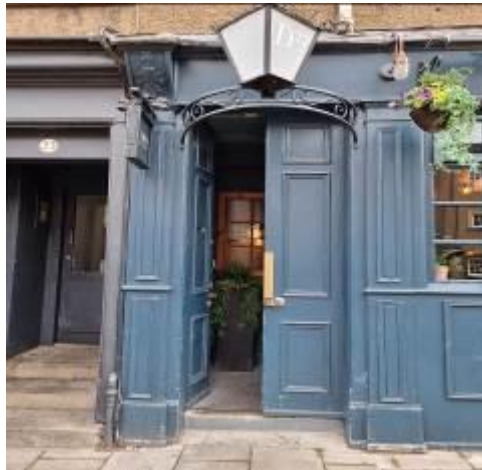
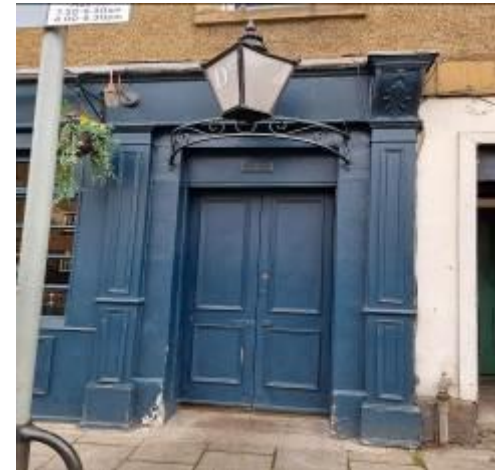
3.0	EXTERNAL					
3.1	Main building		Photos 48-52			
3.1.1	General	Timber framed frontage incorporating four windows, two pairs of double doors and access for beer delivery. Projecting canopy over incorporating two downlights and lead flashing to pebble dash rendered elevation to building above.	2 to 3
