# Schedule of Condition

Property Address:	Dog & Partridge Hotel 44 Friargate Preston PR1 2AT		
Property Reference Number:	2302619101		
	DB/tb	Rev.	
Survey Date	18 <sup>th</sup> April 2019

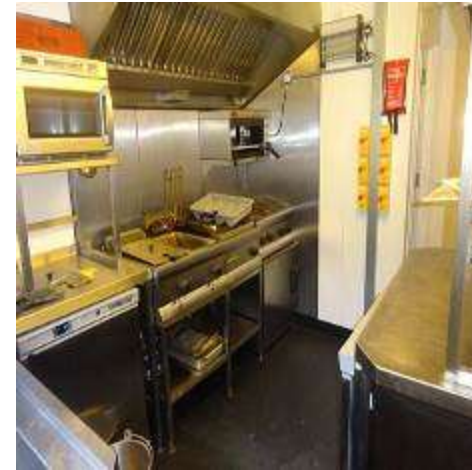
**Photo 019**

Item	Location	Description	Condition Yr0	Condition Re-inspection No 1	Condition Re-inspection No 2	Condition Re-inspection No 3
<b>1</b>	<b>INTERNAL</b>					
<b>1.0</b>	<b>GROUND FLOOR</b>					
<b>1.1</b>	<b>Ground floor accommodation; catering kitchen and adjoining storage rooms</b>		<b>Photos 019 to 020</b>			
<b>1.1.1</b>	<b>Ceiling</b>	Plastered ceilings with emulsion paint finish.	2-1 With dated ceiling surface with slight deterioration to decorative finishes.			
<b>1.1.2</b>	<b>Walls</b>	Plastic sheet lined wall coverings.	2-3 With newer installations present.			
<b>1.1.3</b>	<b>Floor</b>	Vinyl floor cover.	2-3 With newer vinyl floor covering present.			
<b>1.1.4</b>	<b>Internal joinery</b>	Consist of internal face of external windows, internal doors, door frames.	2			
<b>1.2</b>	<b>Ground floor main bar areas including central bar servery and front entrance porchway</b>		<b>Photos 021 to 027</b>

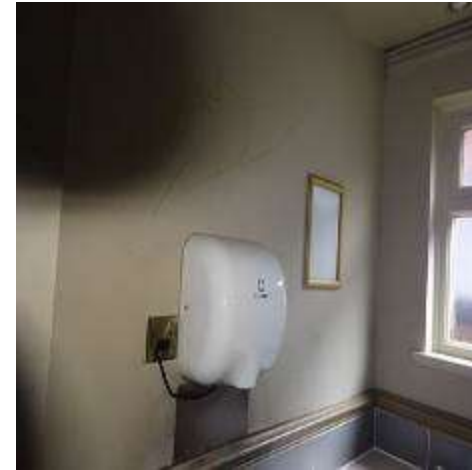
**Photo 031**

1.3.5	Sanitary ware	Consists of ceramic w.c and wash hand basins.	2			
1.3.6	Radiator	Metal panel radiator.	2			
1.4	<b>Ground floor gent's w.c</b>		<b>Photos 030 to 033</b>

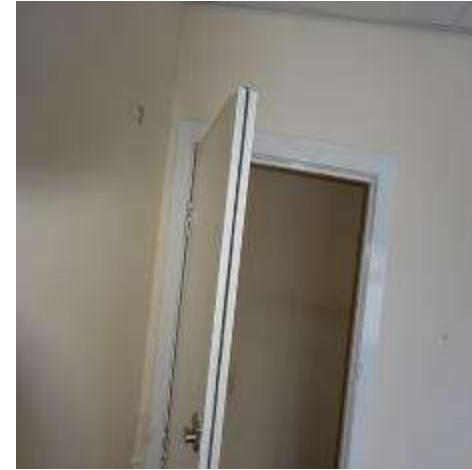
**Photo 043**

3.1.5	Radiator	Metal panel radiator.	2			
3.2	<b>First floor publican residence rear to left hand side elevation bathroom</b>		<b>Photos 042 to 043</b>
