Photographic Schedule of Condition

Masons Arms
Bourne
PE10 9LY

Star Pubs & Bars

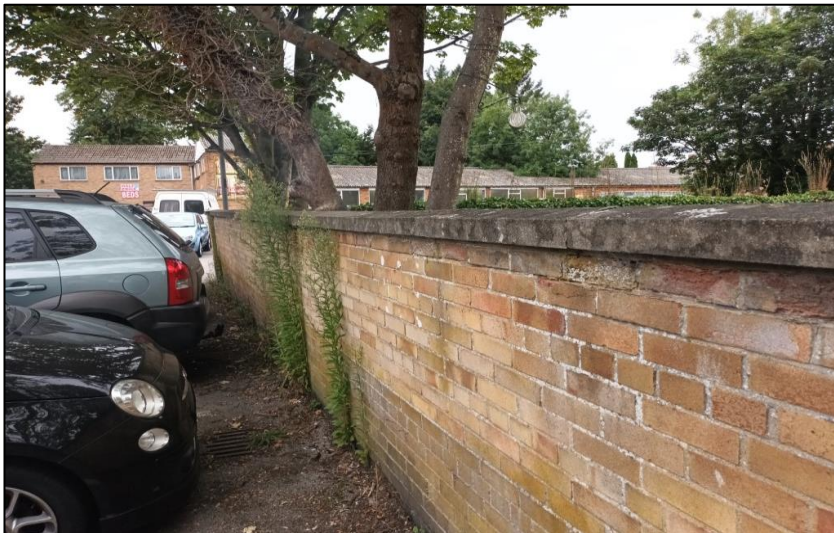
Photograph (38)

4.3	Walls	Brick wall with coping stones to boundary of garden. Spalling brickwork below coping stones on car park elevation.	Poor.	34-41
4.4	Fencing	Fencing to garden compound. Internal inspection not possible.	Poor.	42, 43

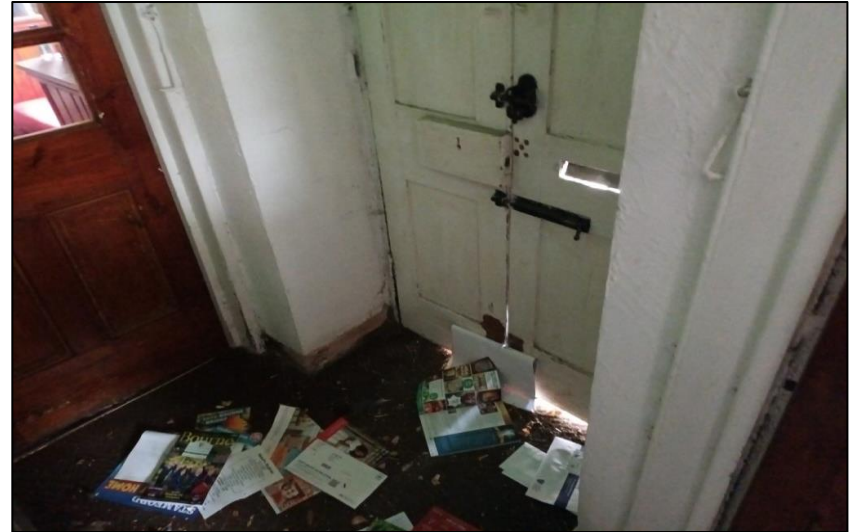
Photograph (45)

4.5	Outbuildings	Timber shed. Decoration required. No access provided internally.	Poor.	44
	INTERNALLY			
5.0	Ground Floor – Front Lobby			
5.1	Floors	Barrier matting carpet is worn.	Poor.	45, 46

5.2	Doors	Stained timber doors to bar area.	Satisfactory.	45, 47
		Decorated timber panelled main entrance door. Numerous gaps, damage and missing threshold at bottom of door.	Poor.	46

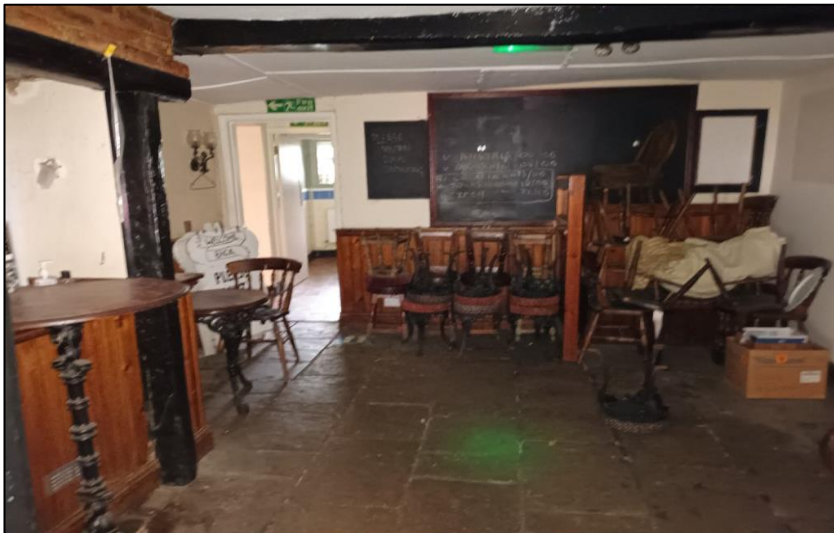
Photograph (50)

Ref:	Location/Element	Description/Comments	Condition	Photo No.
6.0	Ground Floor – Main Trade Area			
6.1	Floors	Stone flag floor surface.	Satisfactory.	50, 51, 59, 60
